Date | 10-28-2019
To | Chisago Lakes LID Board of Managers
cc | Jerry Spetzman
From | Greg Graske

Regarding | Fall Channel and Outlet Structure Inspection

The fall inspection of the Chisago Lakes Outlet Channels and Structures was conducted on September 10th. EOR engineer Greg Graske and District administrator Jerry Spetzman performed the field inspection of the channel system. Dan Lydon, president of the Chisago/Lindstrom Lake Association also attended. The following summarizes the inspection, actions performed, and any future actions recommend. Actions in red are recommended for follow up in the near future, actions in orange are actions that require future follow up or monitoring but are not urgent, and actions in green are maintenance items that were completed recently.

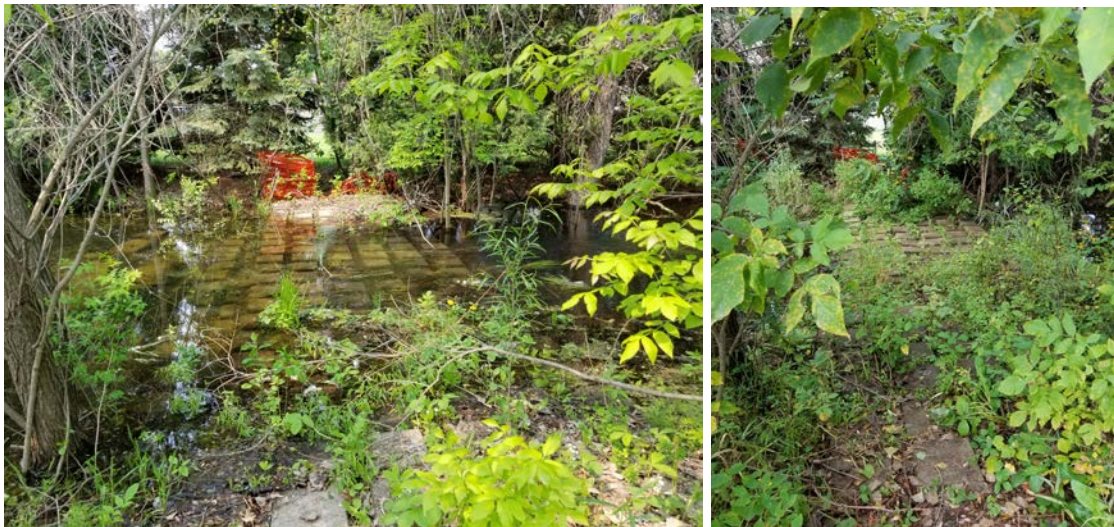
The channel from Chisago Lake to Wallmark Lake was inspected. Chisago Lake water levels rose significantly this spring reaching a peak elevation of 899.5 on May 30th. Water exceeded the weir elevation (899.2) for a period of about three weeks. During this time water overtopped the outlet weir and flowed to Walmark Lake. The trees along the channel section between Highway 8 and North Avenue were cleared last year and the channel is clear of debris. Additional woody debris was also removed from other portions of the channel last year. Damaged fence sections at Paradise Park and the along the trail south of North Avenue were noted. Dan Lydon indicated that he could check in with the parks department regarding repair of the fence. The Sportsman Drive culvert could use some more extensive clean-up of woody debris and rubbish.

Photos: Left – Outlet weir in Paradise Park 5-30-19, Right – Outlet weir 9-10-19

- Further cleanup of woody debris and trash at the Sportsman Drive culvert
- Report damaged fence sections to City or Park department

- Removed debris and trash from Sportsman Drive culvert

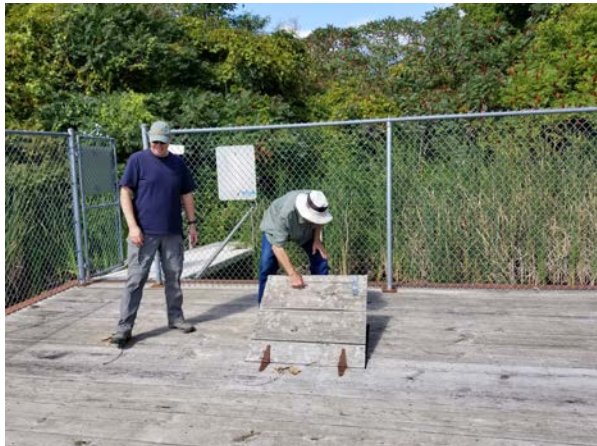
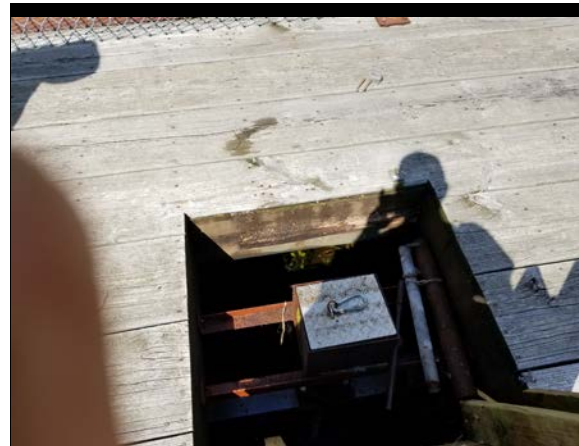
The Green Lake the outlet structure was visited. Due to high water levels the gate was opened on April 10th and will remain open through the fall. Water has been flowing most of the year after the gate was opened. Due to the volume of flow, debris has been collecting at the connection pipes between Lake Ellen and Little Green Lake. These culverts have been cleaned numerous times over to ensure that water continues to flow. Due to recent rain events water levels have risen again. The outlet structure will be left open as long as feasible this fall prior to ice-up on the lakes.

Lily pad roots, vegetation, and wood debris was noted as building up around the weir structure. With the help of several volunteers from the Green Lake Association, the weir was cleaned on June 7th. The debris around the structure will continue to be monitored to determine if future clean outs are needed.

Photo: Left- Lake Ellen weir, Right – Control Box

- Monitor erosion control device in farm field for needed maintenance
- Weed whip trail
- Clean out woody debris located inside control structure (after water recedes)
- Replace rotted support board for control box hatch

- Removal of vegetation and debris at Little Green – Lake Ellen connection

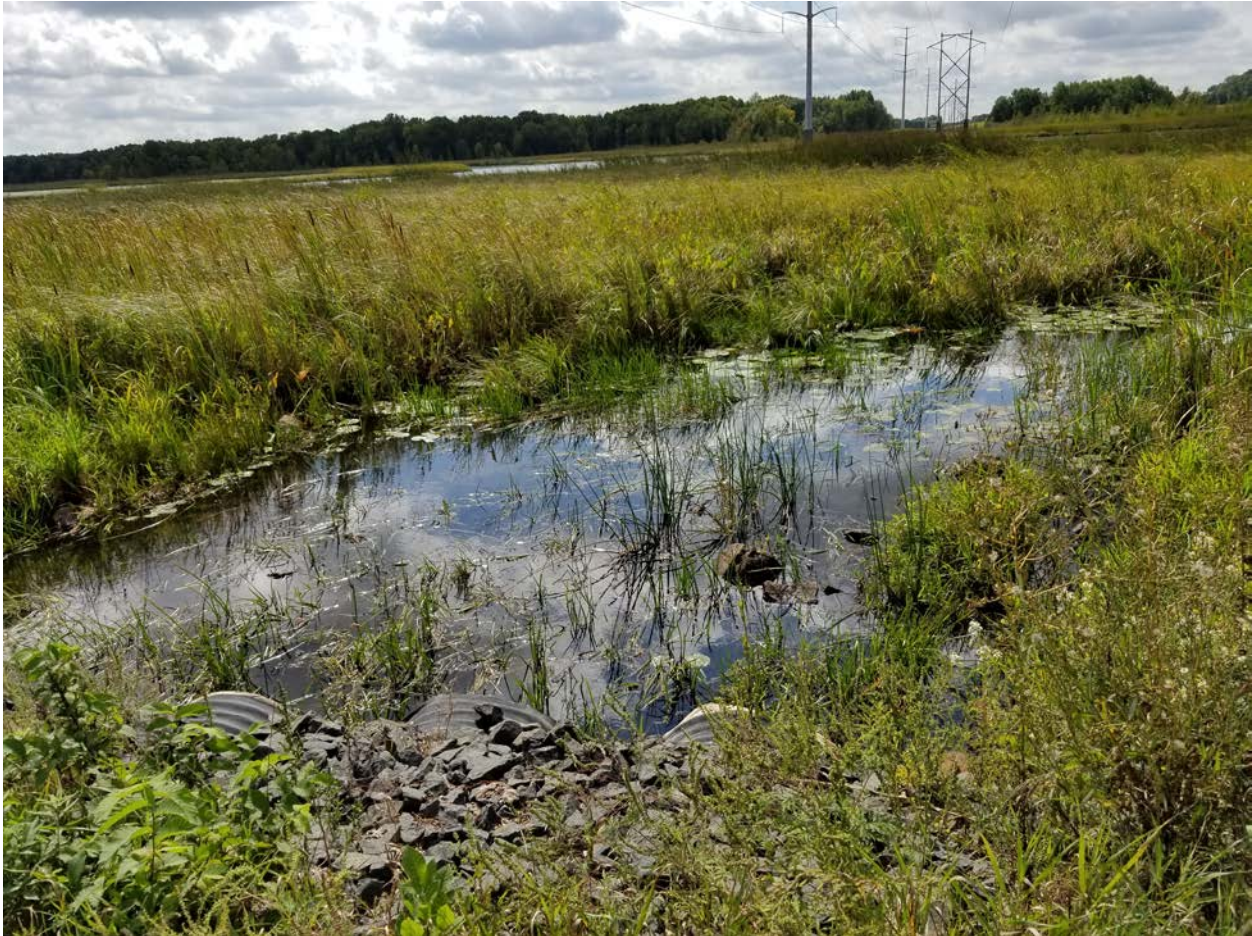
The Swamp Lake outlet pipes under County Road 80 were visited. This location has 7 pipes under the road to convey flow. Water was flowing and no issues were noted. The Operations plan requires closing the Lake Ellen Weir if water levels reach 882.7.

Photo: outlet pipes from Swamp Lake

- Continue monitoring of elevations of Swamp Lake and adjust Lake Ellen outlet weir as required by the management plan.

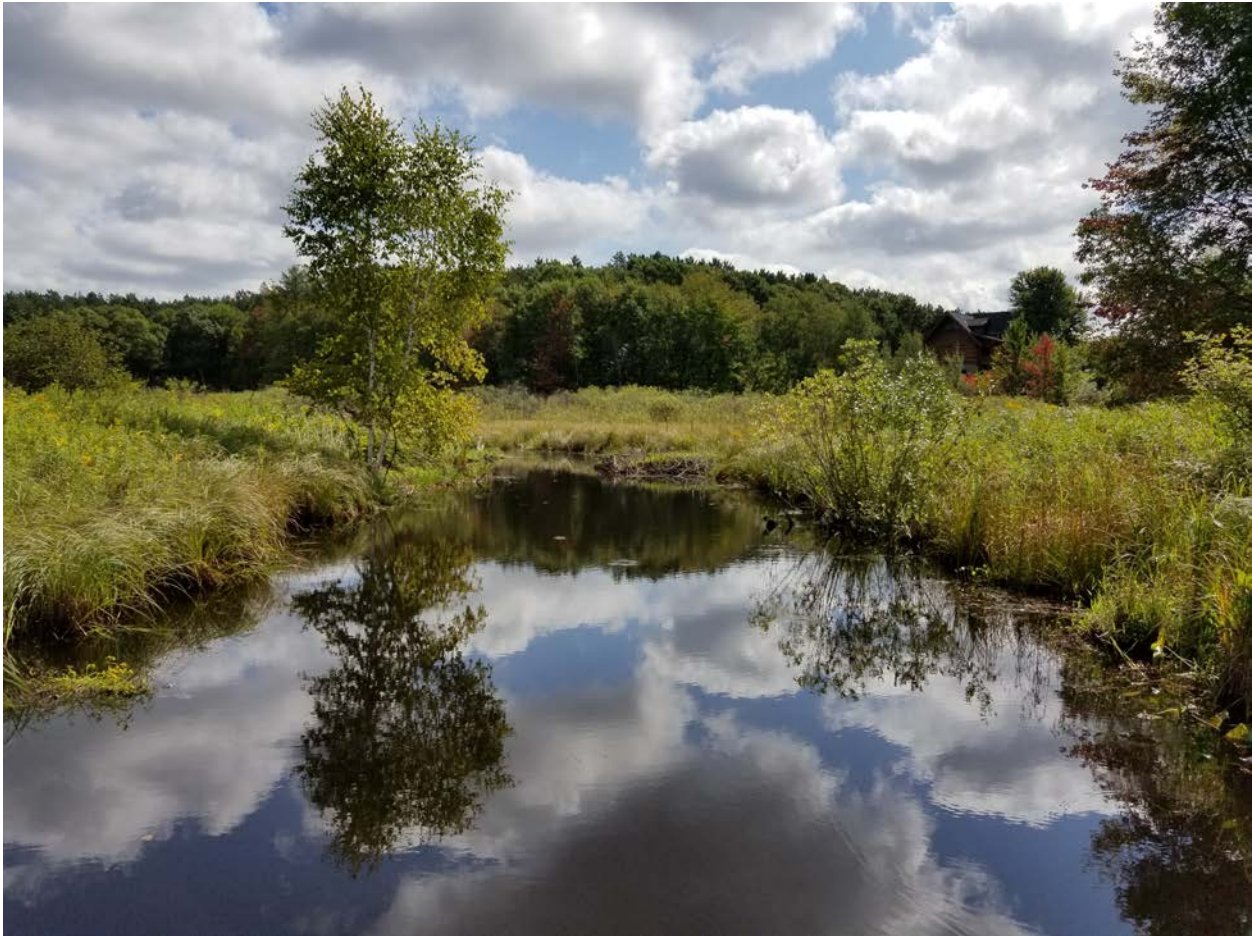
The culvert crossing under Ivywood Trail was visited. This site is not generally part of the outlet conveyance due to the outlet channel to Carlos Avery WMA never being fully completed. A beaver dam was noted during the summer inspection upstream of the Ivywood Outlet. The landowner has since removed half the dam and water is no longer obstructed. It is recommended that this site be observed during future inspections to see if the beavers rebuild the dam.

Photo: Beaver Dam upstream of Ivywood Control Structure

- Monitor for additional beaver activity

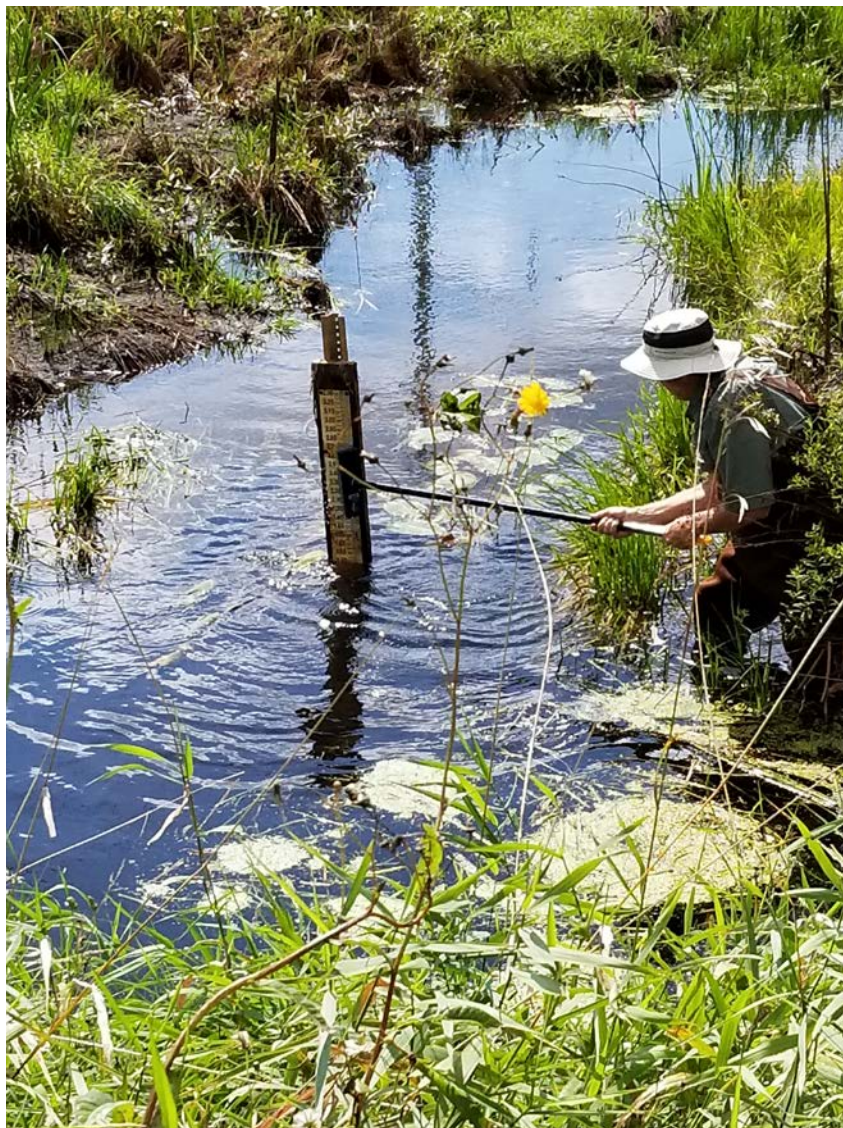
The outlet channel near County Road 19 that flows to Bloomquist creek was visited. Water rose several feet at this location in the spring, but has now receded to a more normal level. The water level gauge was cleaned off during the visit. The LID has easements up to 882.7 (2-feet above the 100-year flood elevation) at this location.

Photo: Upstream of County Road 19

- Continue monitoring water levels at this location.

- Cleaned staff gauge

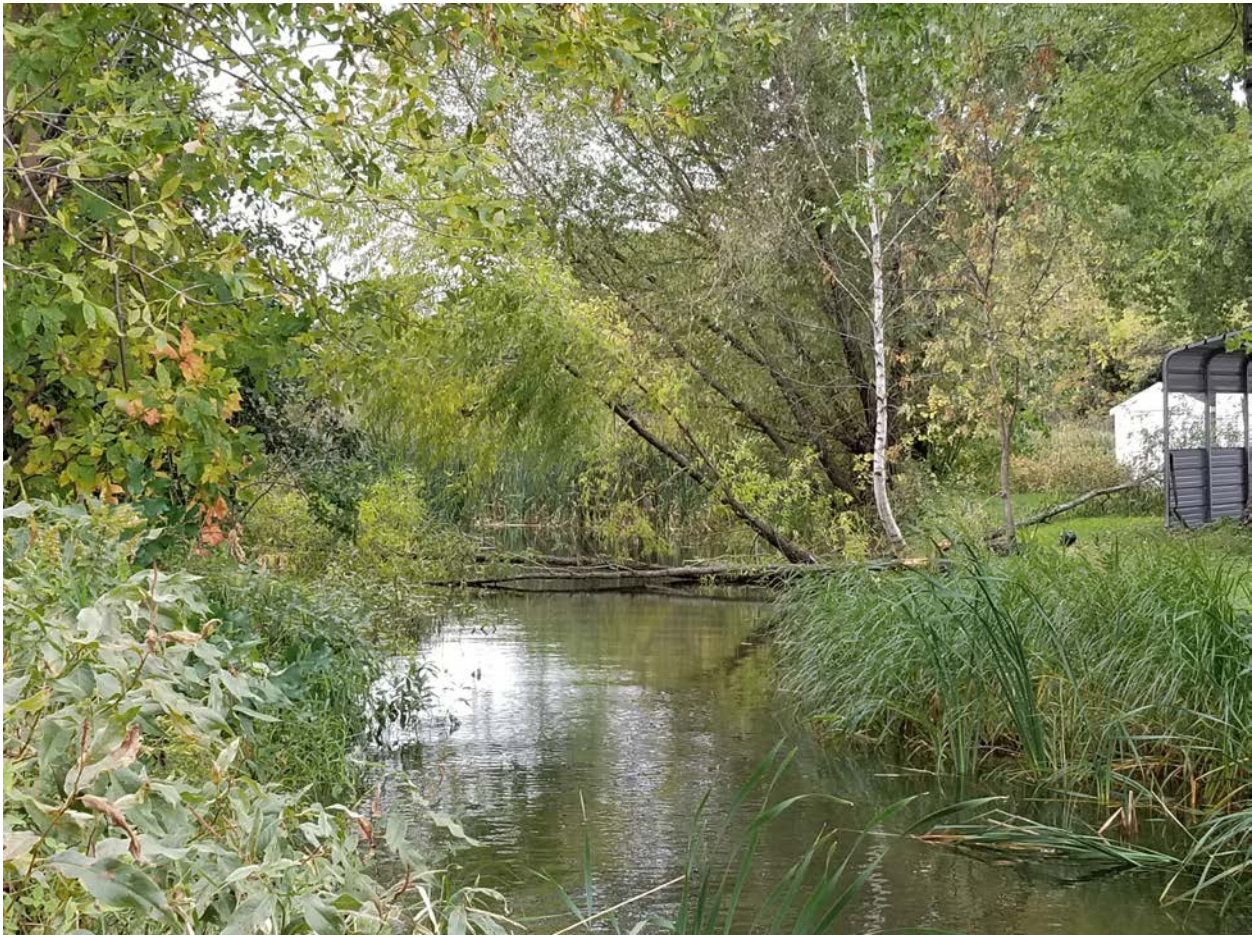
The outlet channel near North Lindstrom was visited on October 3rd. Due to increased water levels boat traffic between North Lindstrom and North Center Lake was feasible earlier in the year. Beaver activity has resulted in trees that have fallen across the channel near North Center Lake. Movement of the bogs in the channel is also hindering boat traffic. The CLLID is considering clearing a path through the bogs in 2020.

Photo: Channel near North Center Lake

- Remove trees that have fallen across channel
- Submit DNR permit for potential bog removal and get quotes for clean out
