Date | 11-20-2020
To | Chisago Lakes LID Board of Managers
cc | Jerry Spetzman
From | Greg Graske

Regarding | Fall Channel and Outlet Structure Inspection

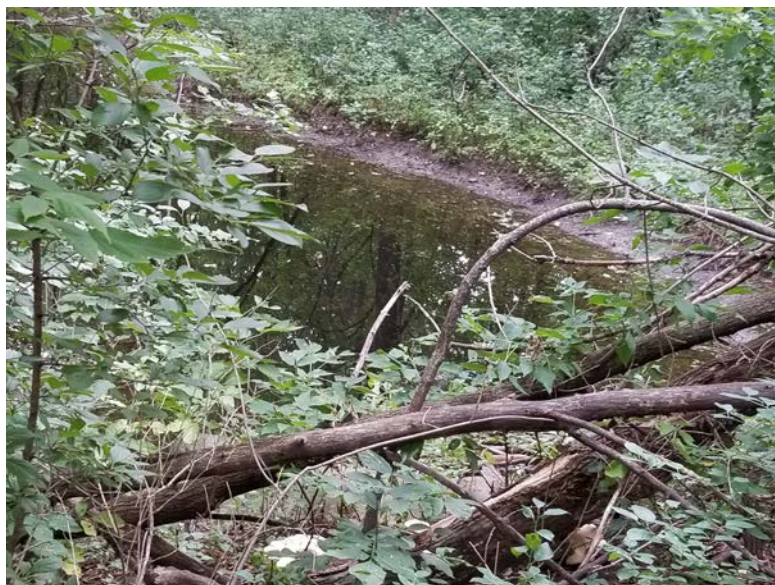
The channel from Chisago Lake to Wallmark Lake was inspected. Chisago Lake water levels were rising this spring, and water started overtopping the weir in early April. Water continued to flow over the weir to Walmark Lake until early May. Water levels have now receded, and water is no longer flowing over the weir. Additional downed trees, trash, and woody debris was noted at both ends of the Sportsman Drive. Some of the debris was cleared around the upstream end of the culvert. It is recommended that a contractor be hired to remove the downed trees and clean up the area.

Photos: Right – Downed trees at Sportsman Drive culvert

- Hire contractor to clean up of downed trees and woody debris at Sportsman Drive culvert

- Cleared debris in area upstream of the Sportsman Drive Culvert

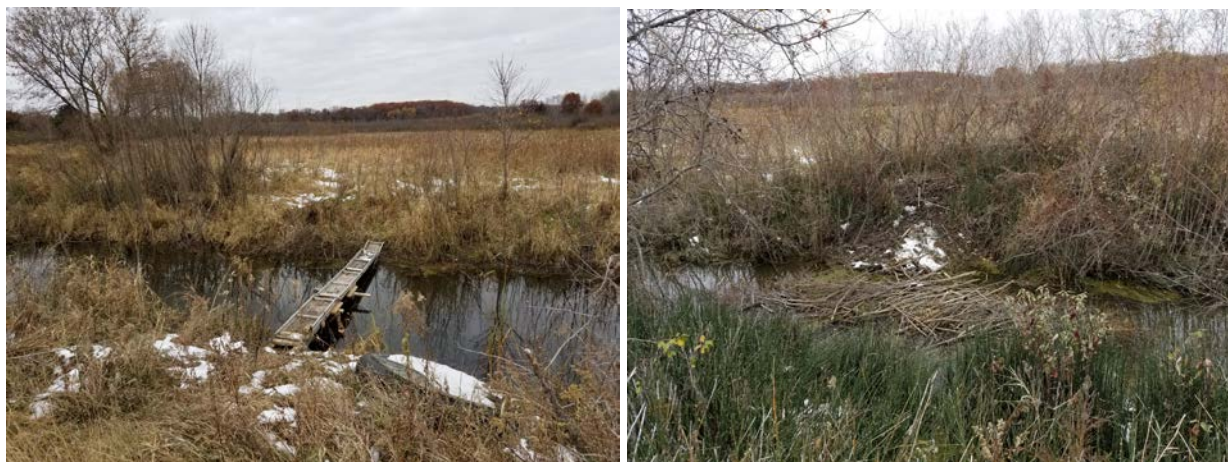
Water was freely flowing from Chisago Lake to Green when the Lofton Weir was open in the spring. At the time of the inspection the Lofton Weir was closed and no water was flowing. A temporary bridge had been placed across the channel for hunting access and the start of a beaver dam was noted. Both items were discussed with the adjacent landowner while in the field. The landowner indicated that he had already contacted a beaver trapper and that the bridge would be removed at the end of the hunting season.

Photo: Left – Temporary Hunting Bridge, Right Beaver Dam

- Remove Beaver Dam

- Confirm that temporary bridge is removed

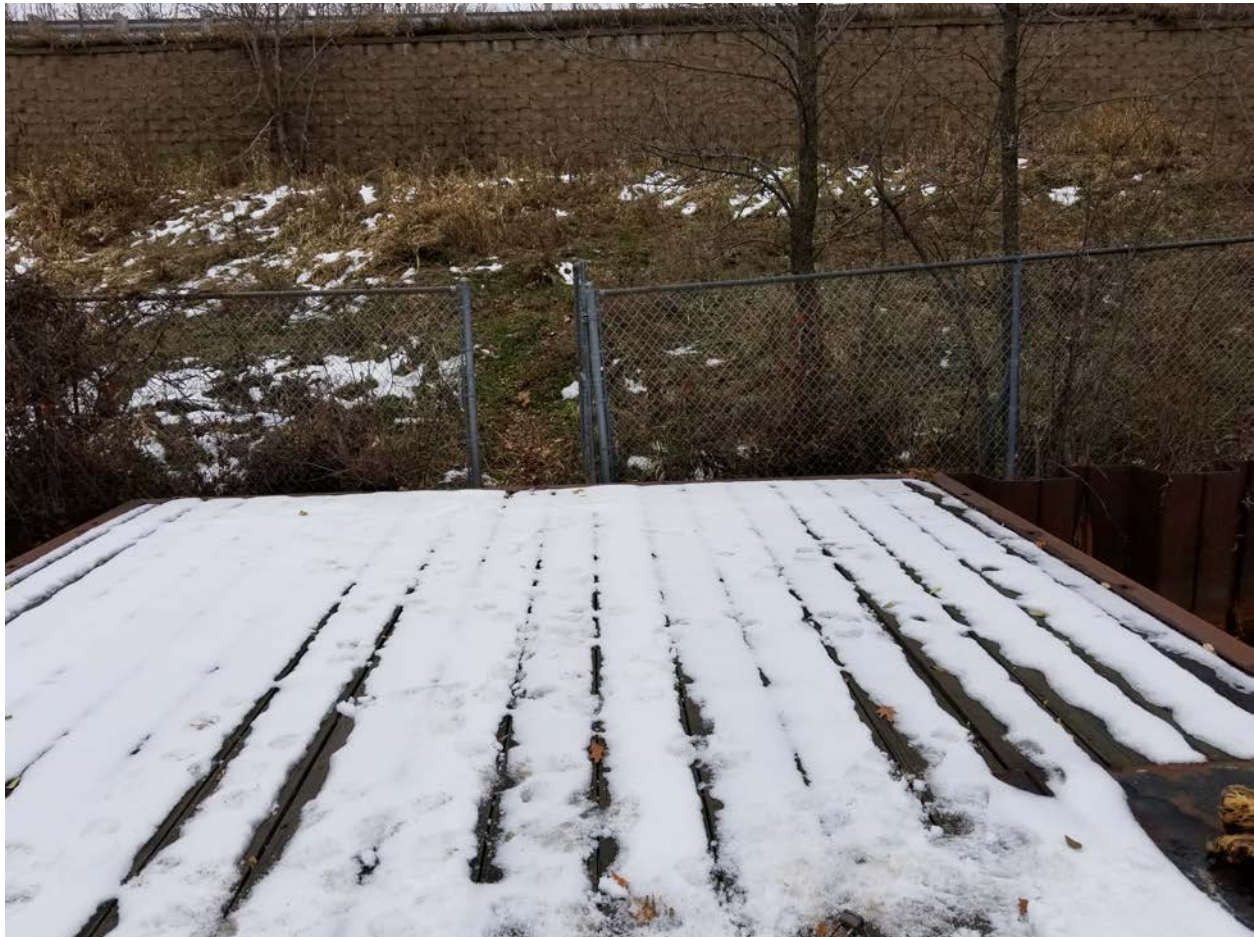
The outlet structure connecting the channel from Chisago Lake to Green Lake was visited. The control gates were opened April 2nd at which time the water level on Chisago Lake was approximately 899.6. Chisago Lake receded to approximately 898.7 on June 11th and the weirs were closed per the approved Channel & Weir Operations and Maintenance Plan. The weirs remained closed for the rest of the year.

Photos: Outlet Control Structure

- Hammered down nails that had popped up
- Raised Gate to prevent freeze up over the winter

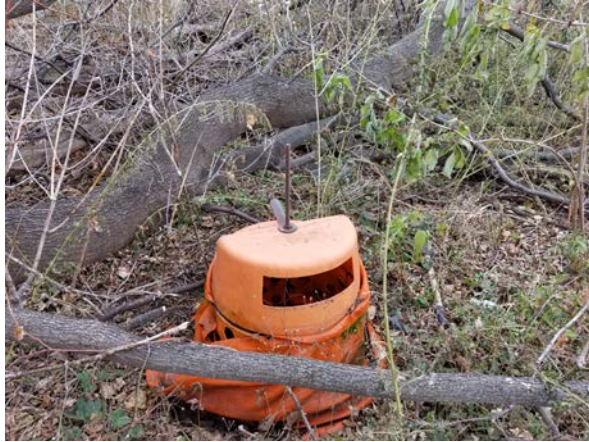
Photo: Erosion control device in farm field

- Monitor erosion control device in farm field for needed maintenance
- Have County survey staff gauge attached to Lake Ellen Weir and the top of the structure next spring

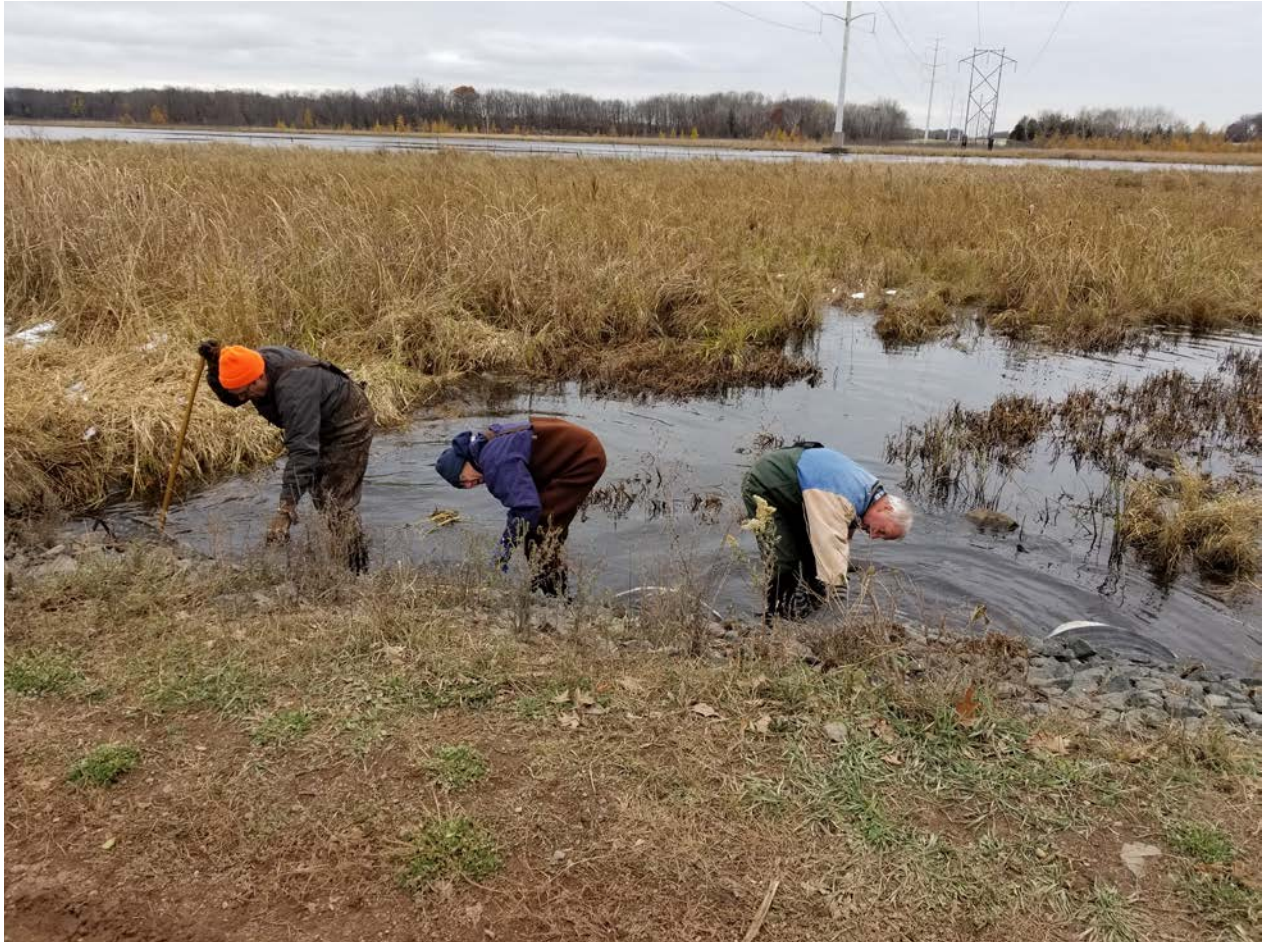
The Swamp Lake outlet pipes under County Road 80 were visited. This location has 7 pipes under the road to convey flow. Water levels peaked at approximately 881.8 on April 30th. The approved Channel & Weir Operations and Maintenance Plan requires closing the Lake Ellen Weir if water levels reach 882.7. Rocks had been noted inside several of the culverts holding back water. These rocks were removed during the inspection.

Photo: removing rocks from outlet pipes at Swamp Lake

- Cleared out rocks from inside of the culverts

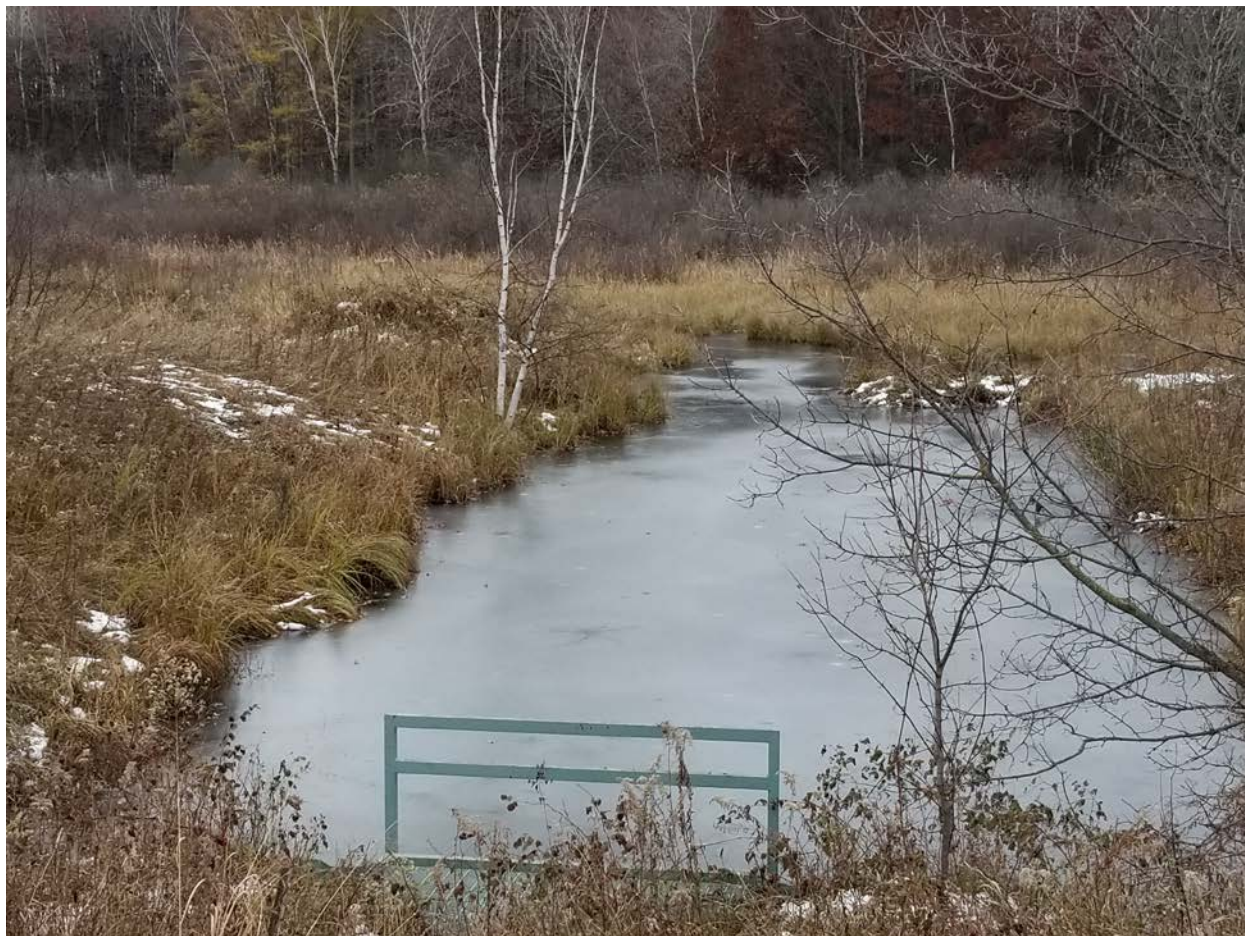
The culvert crossing under Ivywood Trail was visited. This site is not generally part of the outlet conveyance due to the outlet channel to Carlos Avery WMA never being fully completed. No issues were noted. In mid-April someone had propped up one of the stop logs to allow more water to flow through. The stop log was put back in place on April 23rd. A solution to prevent tampering with the weir stop logs should be considered.

Photo: Ivywood Control Structure

- Incorporate locks to prevent tampering with the stop logs

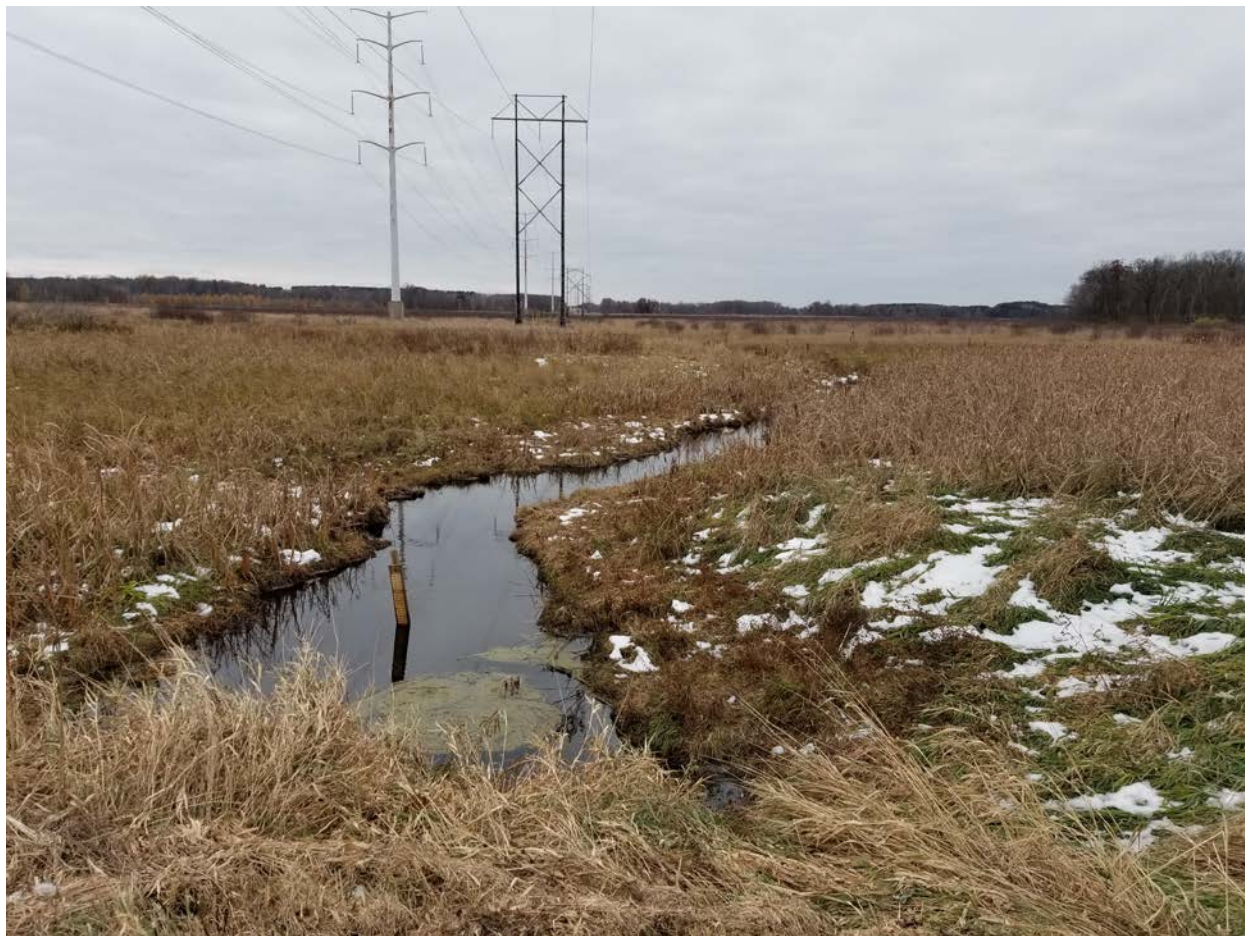
The outlet channel near County Road 19 that flows to Bloomquist creek was visited. Water levels have significantly receded since the spring inspections. No issues were noted.

Photo: Upstream of County Road 19

- Continue monitoring water levels at this location
