To | Chisago Lakes LID Board of Managers

From | Greg Graske

Regarding | Spring Channel and Outlet Structure Inspection

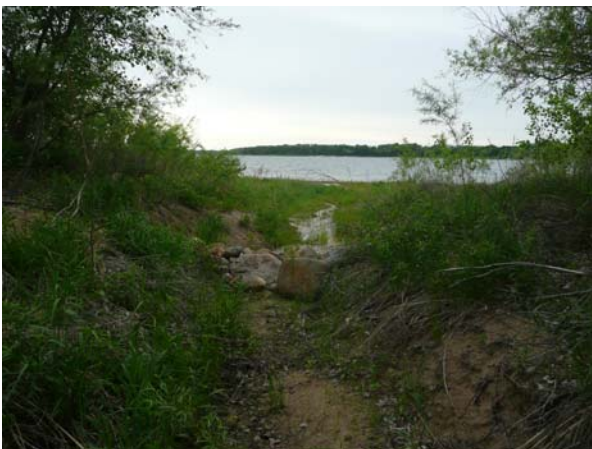
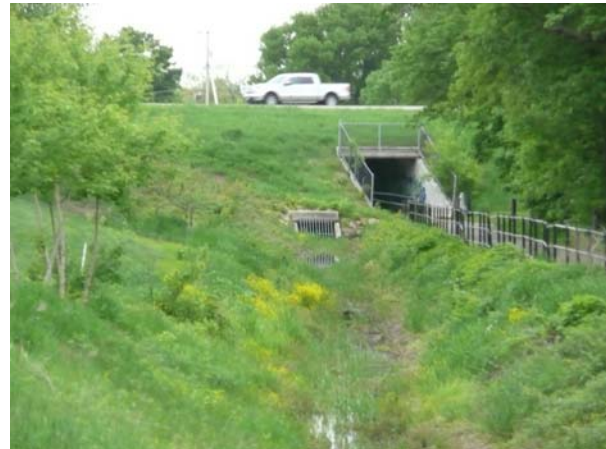
The channel from Chisago Lake to Wallmark Lake was inspected. The channel area near Stinson Avenue appeared to be stable and the existing rock check dam appears to be eliminating any further head cutting and erosion of the channel. During the last inspection there appeared to be continued tampering with the most downstream check dam. Larger boulders were brought in by the contractor to limit the ability to move the rocks. The trees along the channel section between Highway 8 and North Avenue were cleared last year and additional clean-up of the remaining brush is was completed per the recommendation of the last inspection report.

Photos: Left: most downstream check dam with larger boulders, Right: Cleared Channel

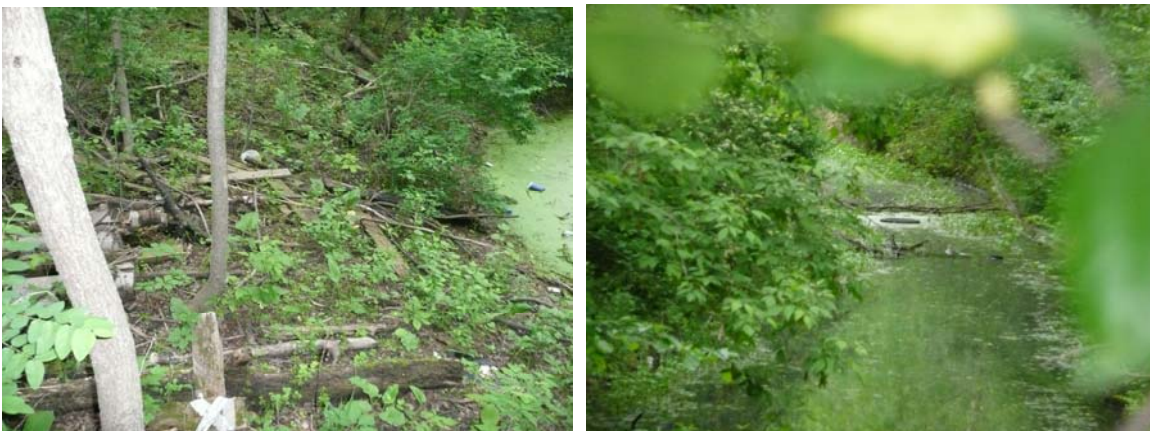
Debris including logs, trash and a tire was noted near the culvert under Sportsmans Drive. It is recommended that this debris be removed along with any other debris upstream and downstream of this crossing.

Photos: debris between North Avenue and Sportsman Drive

- Remove logs and debris in channel between North Avenue and Sportsman Drive

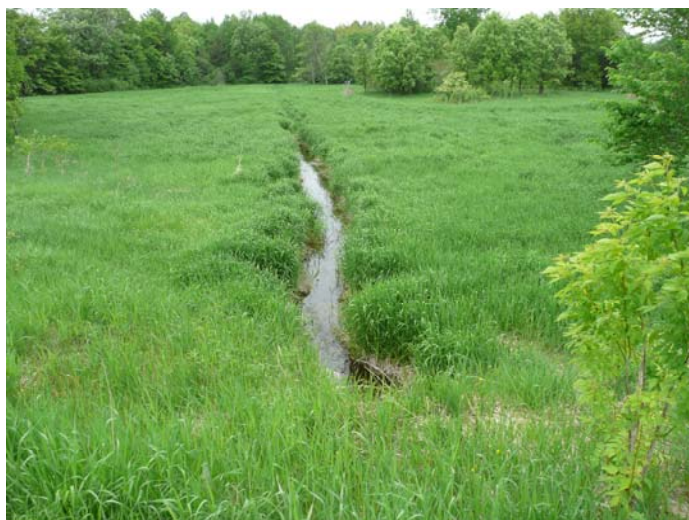
Photo: Channel south of County Road 19

Last inspect this channel was dry due to low water. The channel is currently flowing indicating that water is discharging from Wallmark Lake. No concerns were noted.

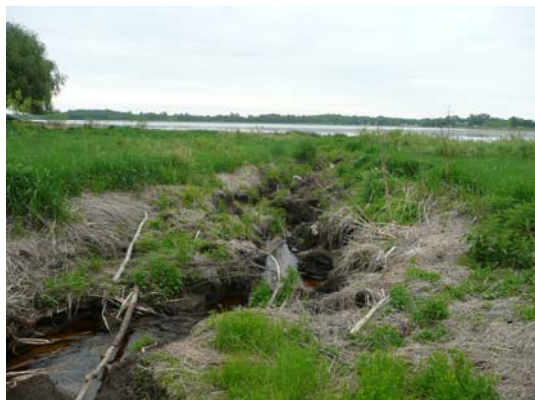
Photo: head cut in channel near Chisago Lake

Some minor debris was noted in the Channel from Chisago Lake to Green Lake. Also, some head cutting has occurred near Chisago Lake which is being caused by backflow from the wetland areas into Chisago Lake. Based on a visual observation this area is all below the OHW of Chisago Lake. It appears that the channel is finding a new equilibrium with no real impact to adjacent property and therefore no action is recommended at this time.

- Continue to monitor debris build up in channel
- Continue to monitor head cutting at channel connection to Chisago Lake

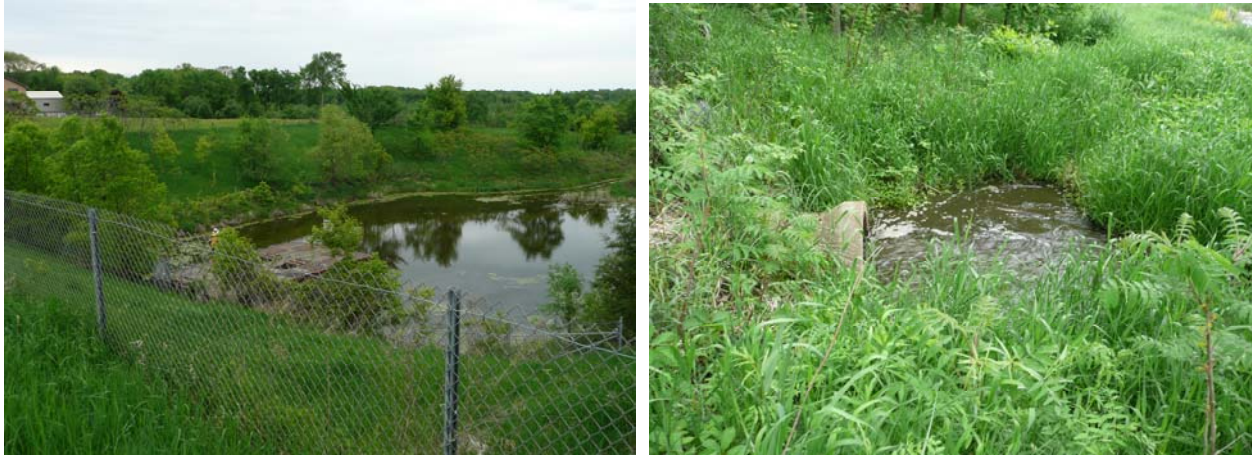
The outlet structure connecting the channel from Chisago Lake to Green Lake was visited. Several repairs were made to the structure last fall. These repairs included fixing one of the gates, fixing the fence, and repairing a leak. The gates were tested and were working correctly. Water was observed flowing from the wetland area to Green Lake when opened. The gates were returned to the closed position upon completion of the inspection.

Photos: Left: Outlet Structure, Right: Water flowing to Green Lake

- Monitor site for continued beaver activity and need for beaver control.

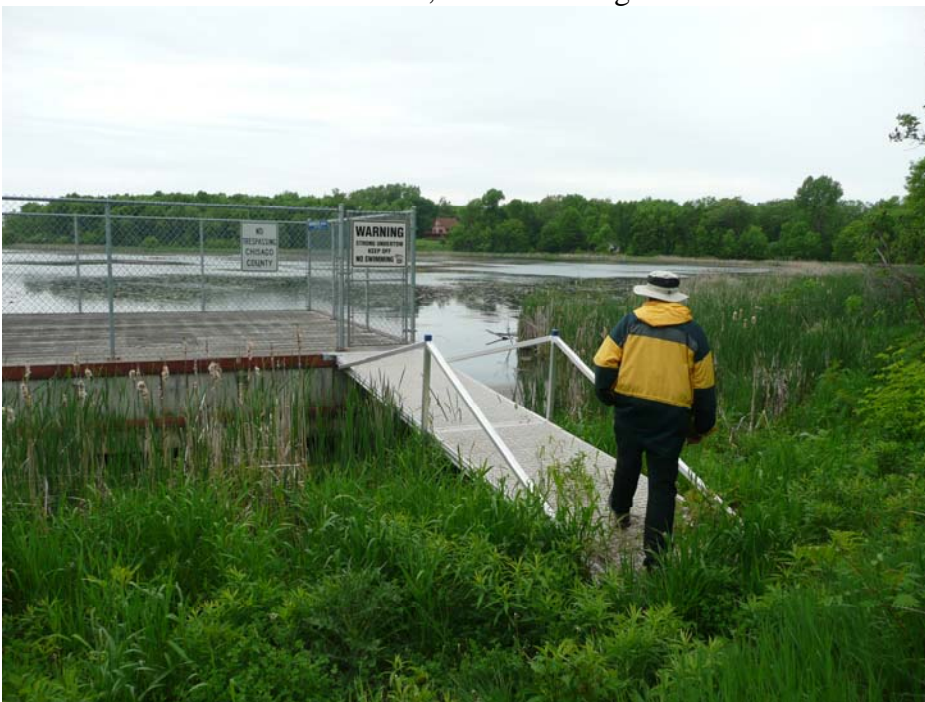
Photo: Lake Ellen Outlet Structure

A repair to the gate mechanism, clearing of vegetation and replacement of the missing control box cover was completed last fall. The gate was exercised and appeared to be operational. The emergency management plan calls for the gate to be open when the lake level is 891.5. The plan also says that the gate may remain closed when lake levels are below 891.0. Lake Ellen was below the weir overflow elevation; therefore the gate was left closed.

- Monitor Beaver Activity going forward and determine need for additional beaver control.
- Monitor Erosion Control Device in farm field for needed maintenance

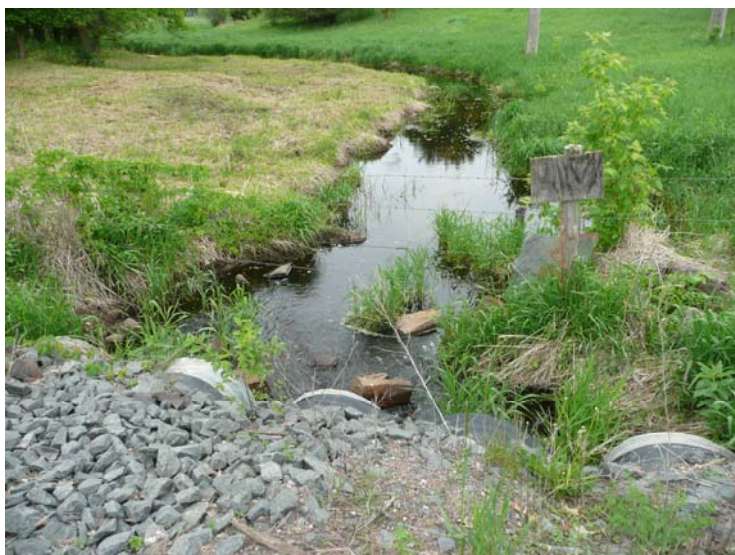
The Swamp Lake outlet pipes under County Road 80 were visited. This location has 7 pipes under the road to convey flow. Obstructions previously noted have been removed. No concerns were noted.

Photos: Pipes leaving Swamp Lake

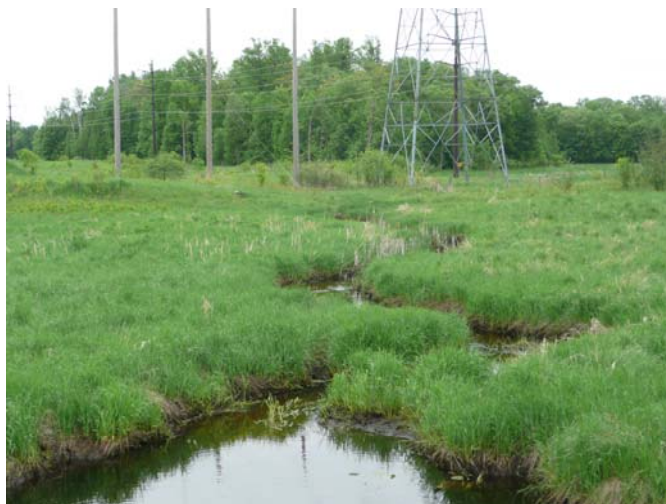
North of the Creek Crossing at County Road 19 there is a pinch point that has been historically used by Beavers. The District has obtained easements over this area and has discussed with the

landowner about some modifications to limit this pinch point to reduce the likelihood of water backups from Beavers. If this work is desired to be completed, it is important that the base channel configuration is minimally impacted as to not destabilize the channel. Modifications that widen the floodplain to match up and downstream would be acceptable assuming proper revegetation and stabilization is implemented at the same time as the modifications.

Photos: Bloomquist Creek at north of County Road 19

- **Modify floodplain to minimize pinch point north of County Road 19 if directed by the CLLID Board. Any modifications should be overseen by EOR's Steam Specialist.**
