Date | 5-4-2012

To | Chisago Lakes LID Board of Managers

Regarding | Spring Channel and Outlet Structure Inspection

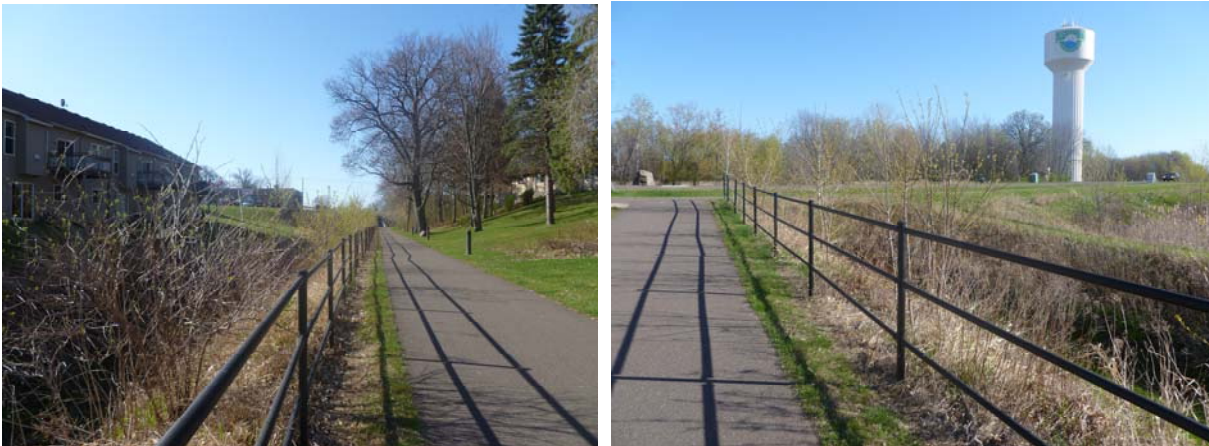
The length of the channel from Chisago Lake to Wallmark Lake was inspected. The channel area near Stinson Avenue appeared to be stable and the existing rock check dam appears to be eliminating any further head cutting and erosion of the channel. The channel section between Highway 8 and North Avenue is relatively free of debris however numerous small trees are starting to grow along the bank of channel. This provides a visual barrier but may also limit future access in the future if they are allowed to continue to get larger. It is recommended that the Board consider the pro vs. cons of removal of these theses small tree located along this channel section.

Photos: Channel between Highway 8 and North Avenue

- Consider Removal of Trees between Highway 8 and North Avenue
- Remove branches in channel near tot lot
- Remove logs and board in channel between North Avenue Sportsman Drive

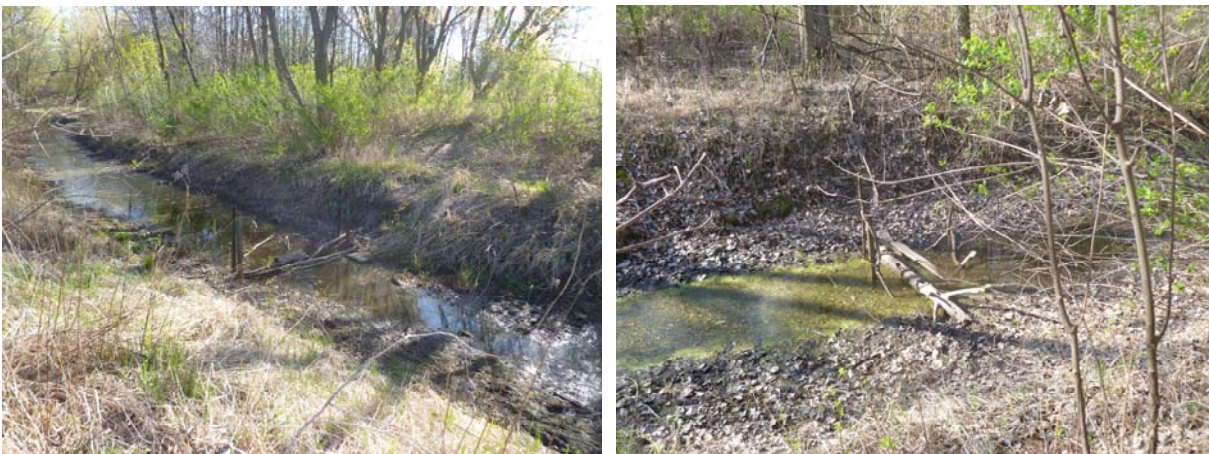
Logs and Boards were noted in the channel in several locations between North Avenue and Sportsman Drive. This debris should be removed from the channel.

Photos: debris between North Avenue and Sportsman Drive

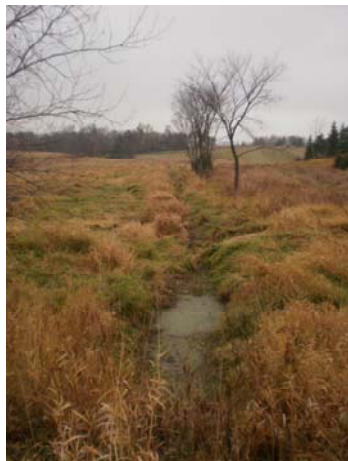
Channel from Wallmark Lake to County Road 19

No concerns were noted.

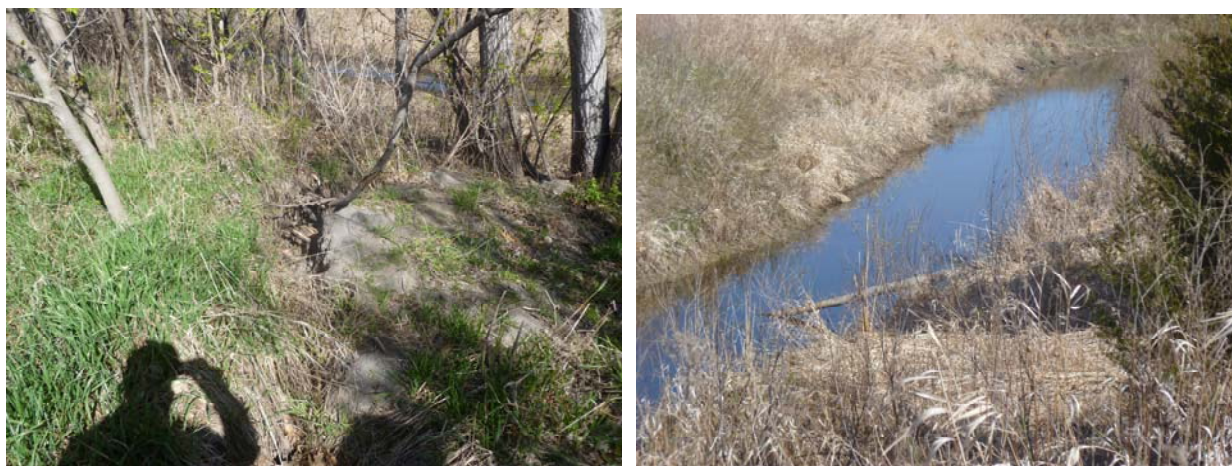
Two falls ago some erosion areas from flow being delivered off the adjacent farm field were repaired by the contractor. One of the areas is holding up well, while the other area is starting to see some of the erosion return. This was previously noted but was not a high priority item and assess is limited. Follow up repairs when possible are recommended to prevent future erosion and sediment transport into the channel.

Photos: Left: Erosion cause by flow from adjacent farm field, Right: Downed Tree in Channel

- Follow up corrective action at erosion site in fall after harvest
- Remove downed tree

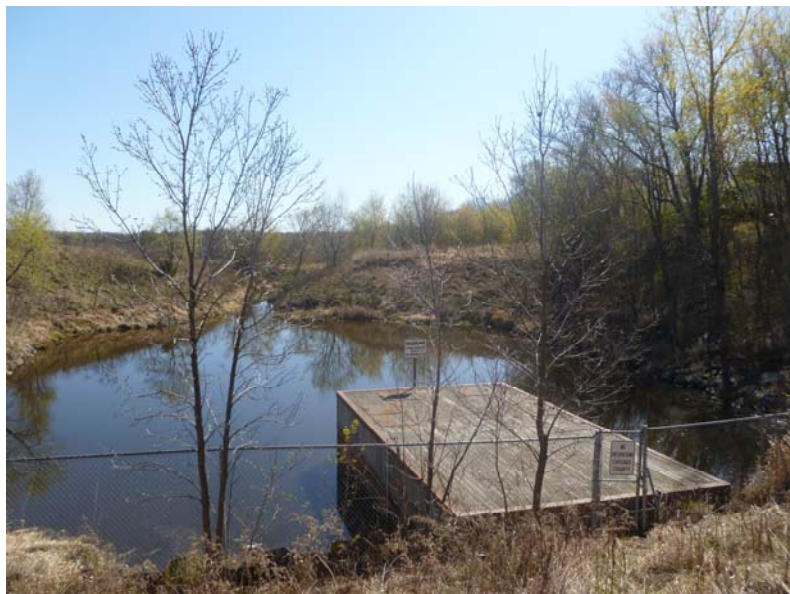
The outlet structure connecting the channel from Chisago Lake to Green Lake was visited. The structure was cleared of debris two years ago and the structure is still clear of debris. The gates were opened to test operation and water did flow through the structure to Green Lake. Muskrats have been observed at the outlet of the pipe during the last two inspections. Six muskrats were flushed out when the gates were opened. The gates were returned to the closed position upon completion of the inspection.

Photos: Outlet structure from Chisago to Green

- Monitor site for continued beaver activity and need for beaver control.

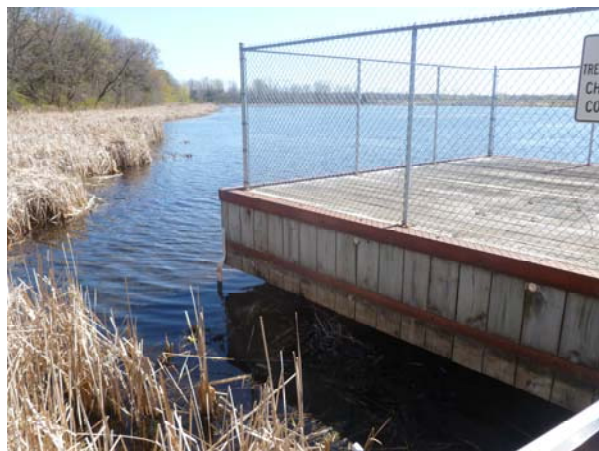
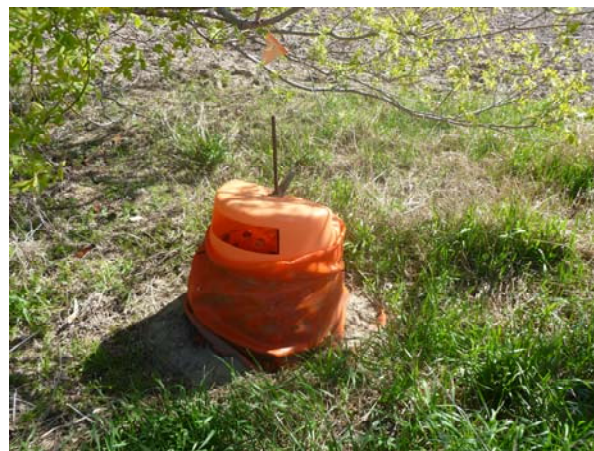
The outlet structure on Lake Ellen was visited. Debris was removed from around the Lake Ellen two years ago. The gate was exercised and appeared to be operational. The emergency management plan calls for the gate to be open when the lake level is 891.5. The plan also says that the gate may remain closed when lake levels are below 891.0. Lake Ellen was below the weir overflow elevation; therefore the gate was left closed. No new beaver activity was observed. The erosion control device installed on the catch basin located over the outlet pipe in the farm field appeared to be working as intended.

Photo: Left: Lake Ellen weir, Right: Catch Basin with Erosion Control Cover

- Monitor Beaver Activity going forward and determine need for additional beaver control.
- Open gates and test for flow when water gets high-enough
- Monitor Erosion Control Device for needed maintenance

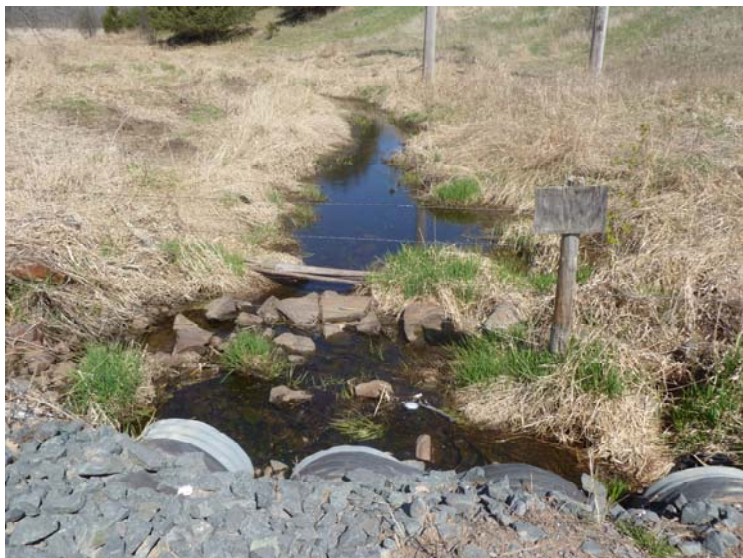
Photos: Pipes leaving Swamp Lake

- Remove rock placed across the channel downstream of the pipes

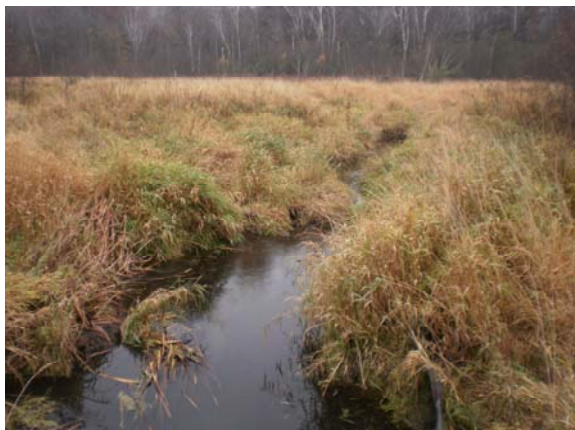
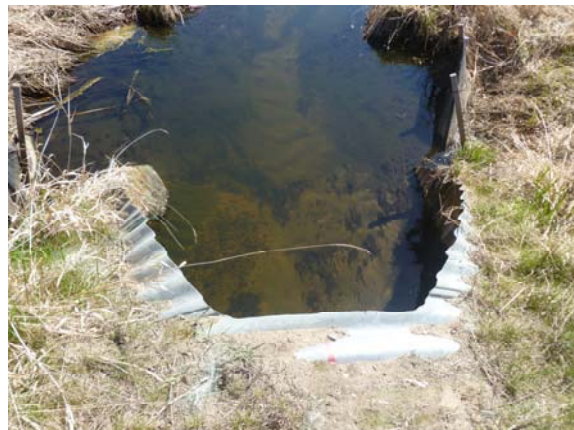
The Bloomquist Creek Crossing at Ivywood Trail was visited. A new culvert had recently been installed at this location. Water was flowing through the stream and no maintenance issues were noted. The Bloomquist Creek Crossing at County Road 19 was also visited and water was flowing at this location as well.

Photos: Bloomquist Creek at Ivywood Trail

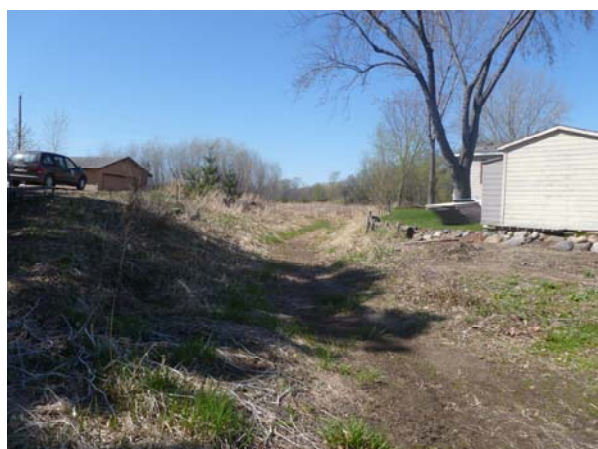
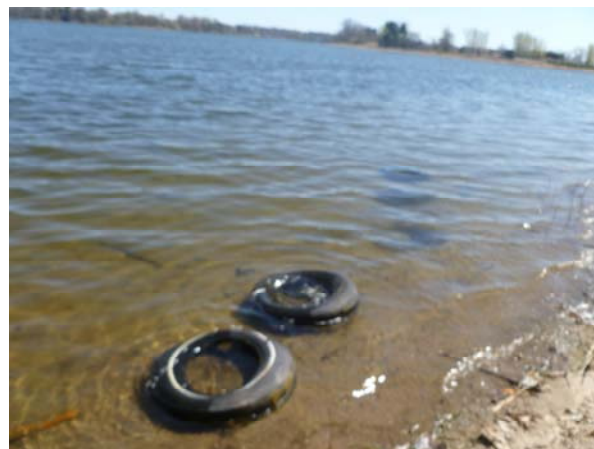
The channel at the outlet of North Center Lake was visited. The contractor had removed the trees near the channel outlet as requested by the Board. While out at the site a significant amount of debris was noted along the shoreline of North Center. Although not part of the channel system it is recommended that this area be cleaned up if possible.

Photos: Left: Channel outlet for North Center Lake, Right: Tires along shoreline of North Center Lake
