LINDEN STREET RECONSTRUCTION

WATER QUALITY PROJECTS

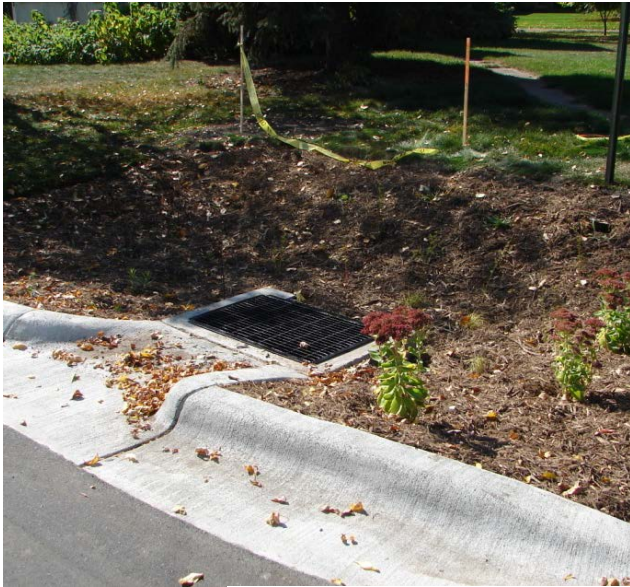
The City of Lindstrom partnered with the Chisago Soil & Water Conservation District to solve erosion problems that were occurring at the end of Linden Street, a dead-end road with a steep slope to the lake. This project has two curb cut rain gardens at the top of the hill, on either side of Linden Street. These

capture stormwater runoff from nearby roads before it runs down Linden Street.

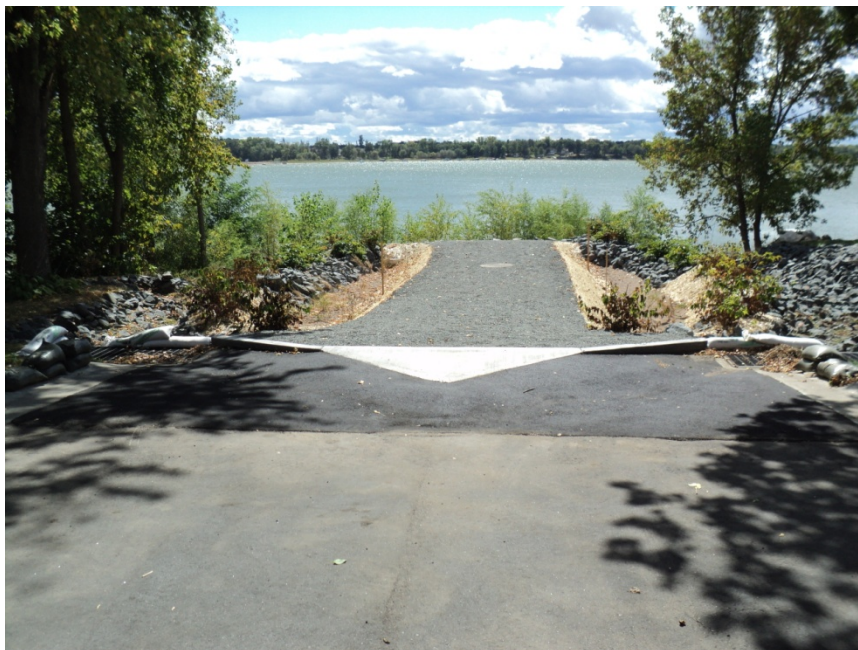
At the end of Linden Street are two more linear rain gardens. What you can't see is an underground sand/iron filter that removes phosphorus from the water. The phosphorus binds to the iron fillings and is kept out of South Lindstrom Lake. The large rock swales are emergency overflow for large storms that overwhelm the rain gardens and filter.
