# CENTER CITY – MOBECK AVENUE

## RAIN GARDENS

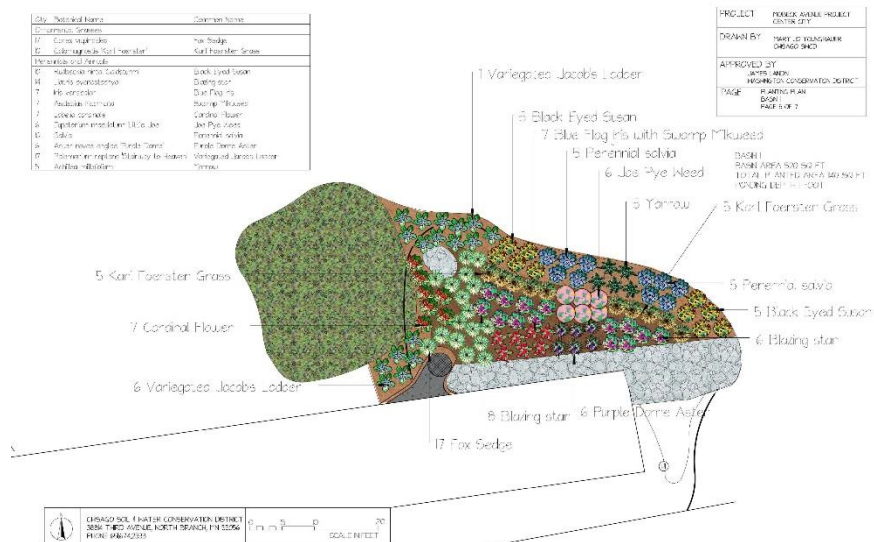
A new rain garden was installed along Center Avenue, near the intersection with Mobeck Avenue, to help reduce some of the volume flowing downhill to the existing rain gardens. On the dead end portion of Mobeck, there is a crest in the road, after which runoff drains down a steep slope into South Center Lake. A large rain garden and a smaller boulevard rain garden were installed to capture the runoff, infiltrate as much as possible, and safely transport the remaining water to the bottom of the hill without causing erosion.

Construction was put on hold when snow fell and the ground froze. The finishing touches and planting will be done in the spring!
